EXTERIOR DESIGN DEVELOPMENT

JANUARY 31 2023

**HUNTINGTON NATIONAL BANK
6 MILE + HAGGERTY**

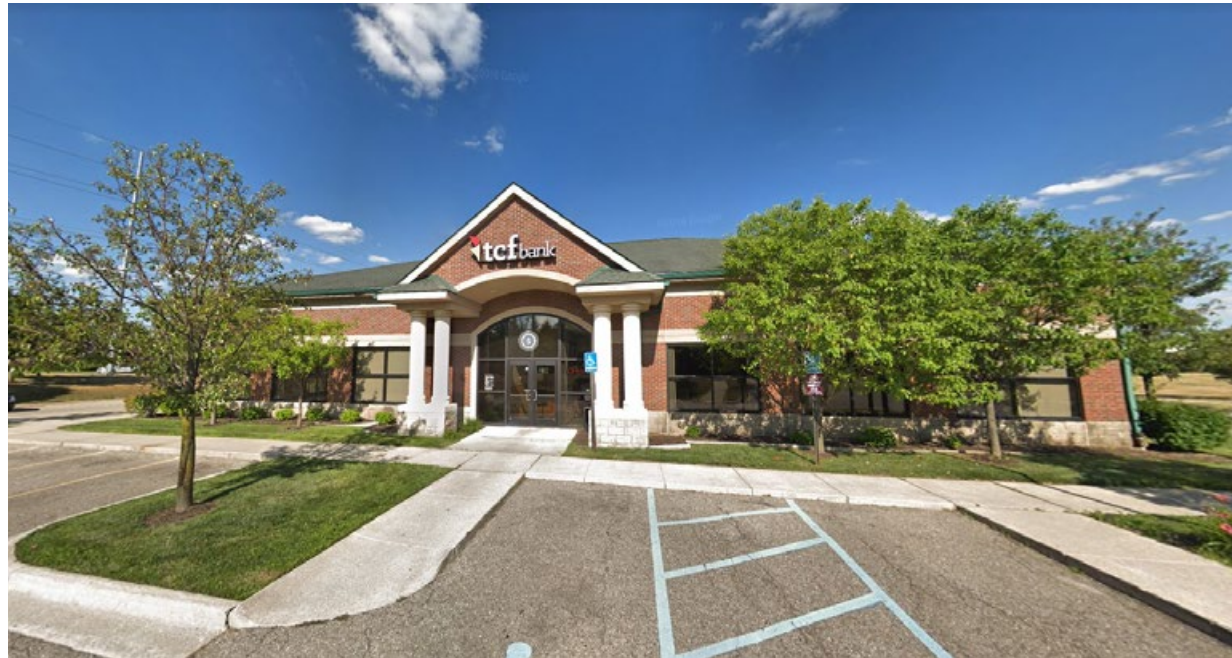
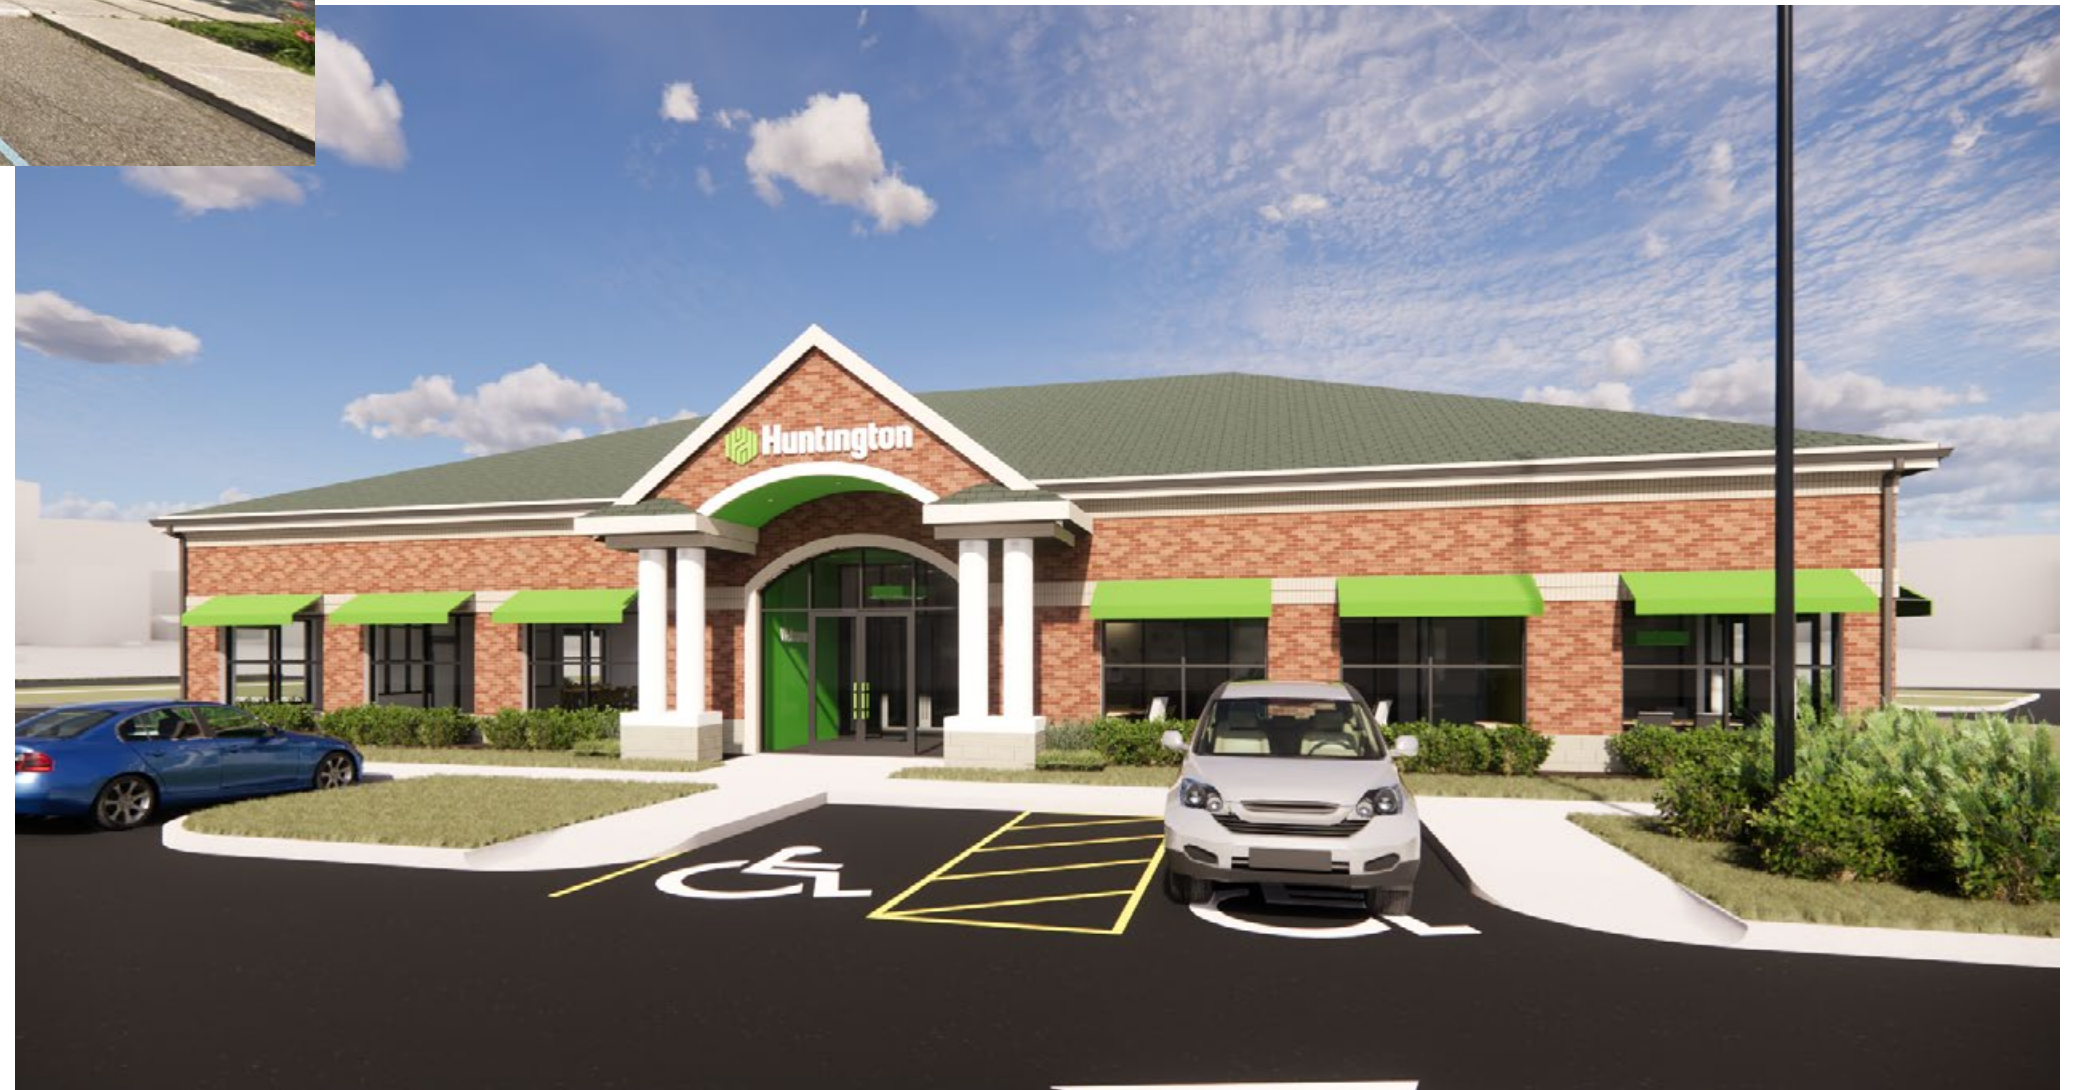
- Existing portico and columns to remain.
- Replace front doors and expand vestibule.
- Install fabric awnings over windows.
- Paint underside of portico brand green.

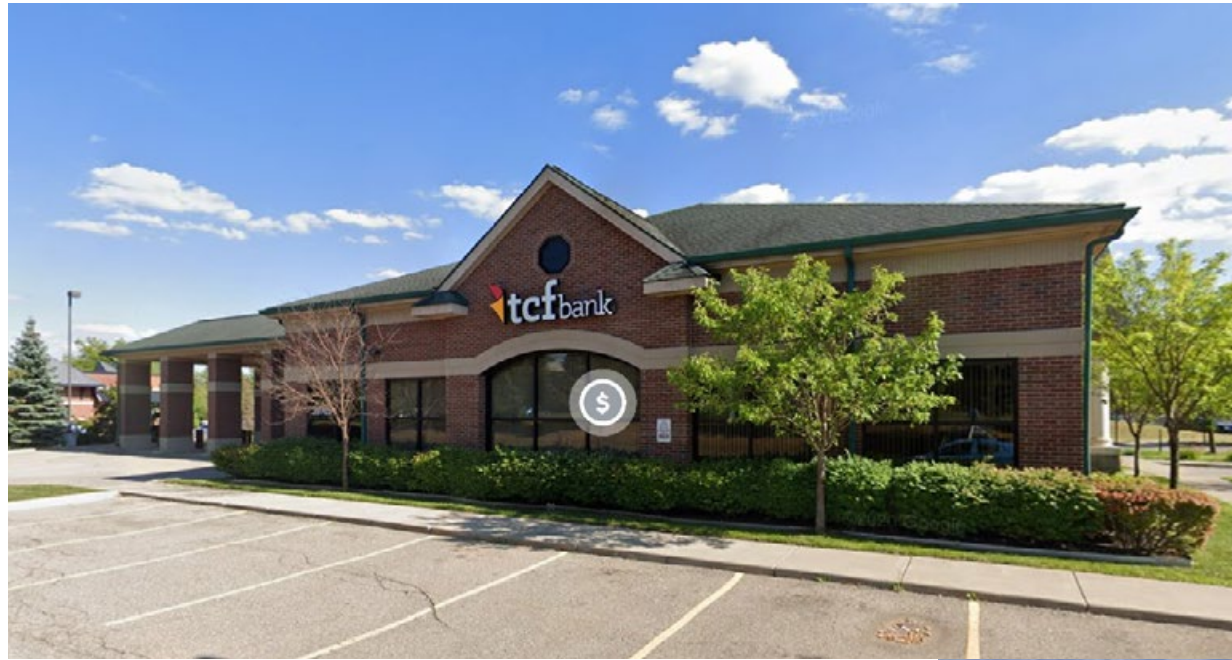
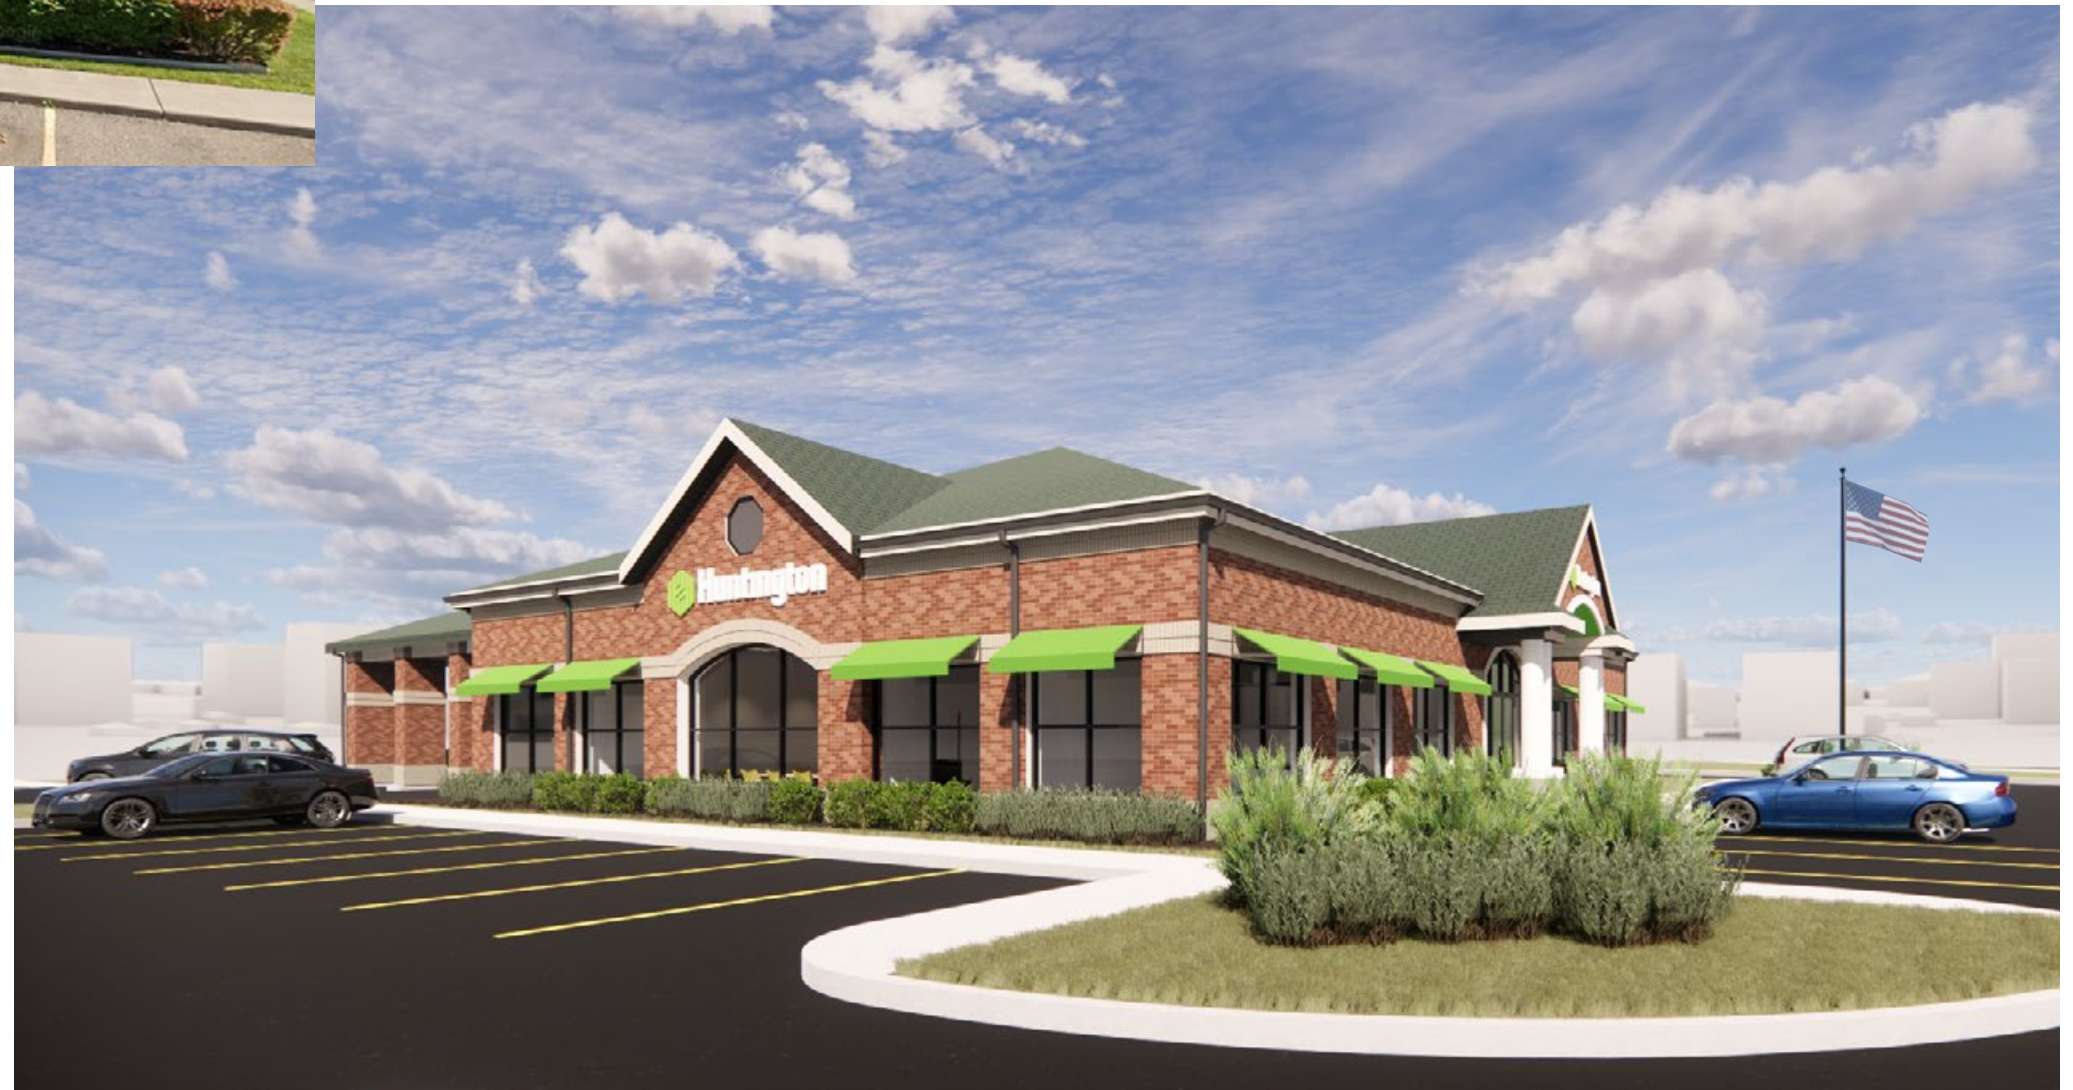
- Existing exterior to remain.
- Install fabric awnings over windows.

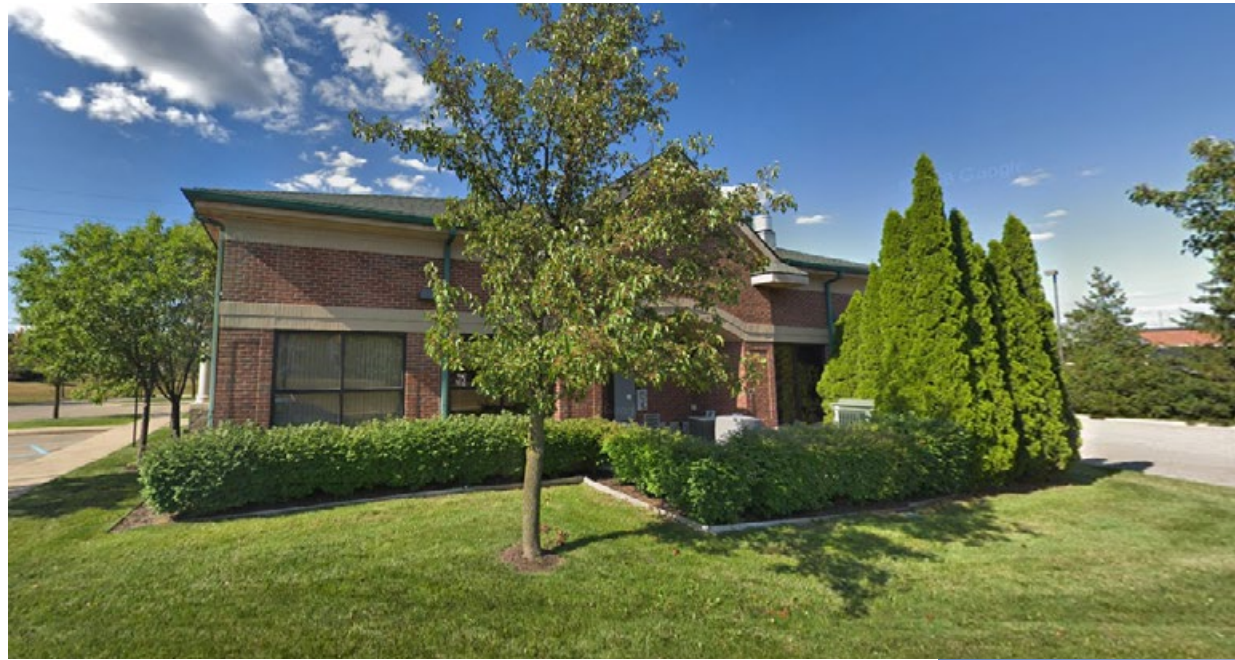
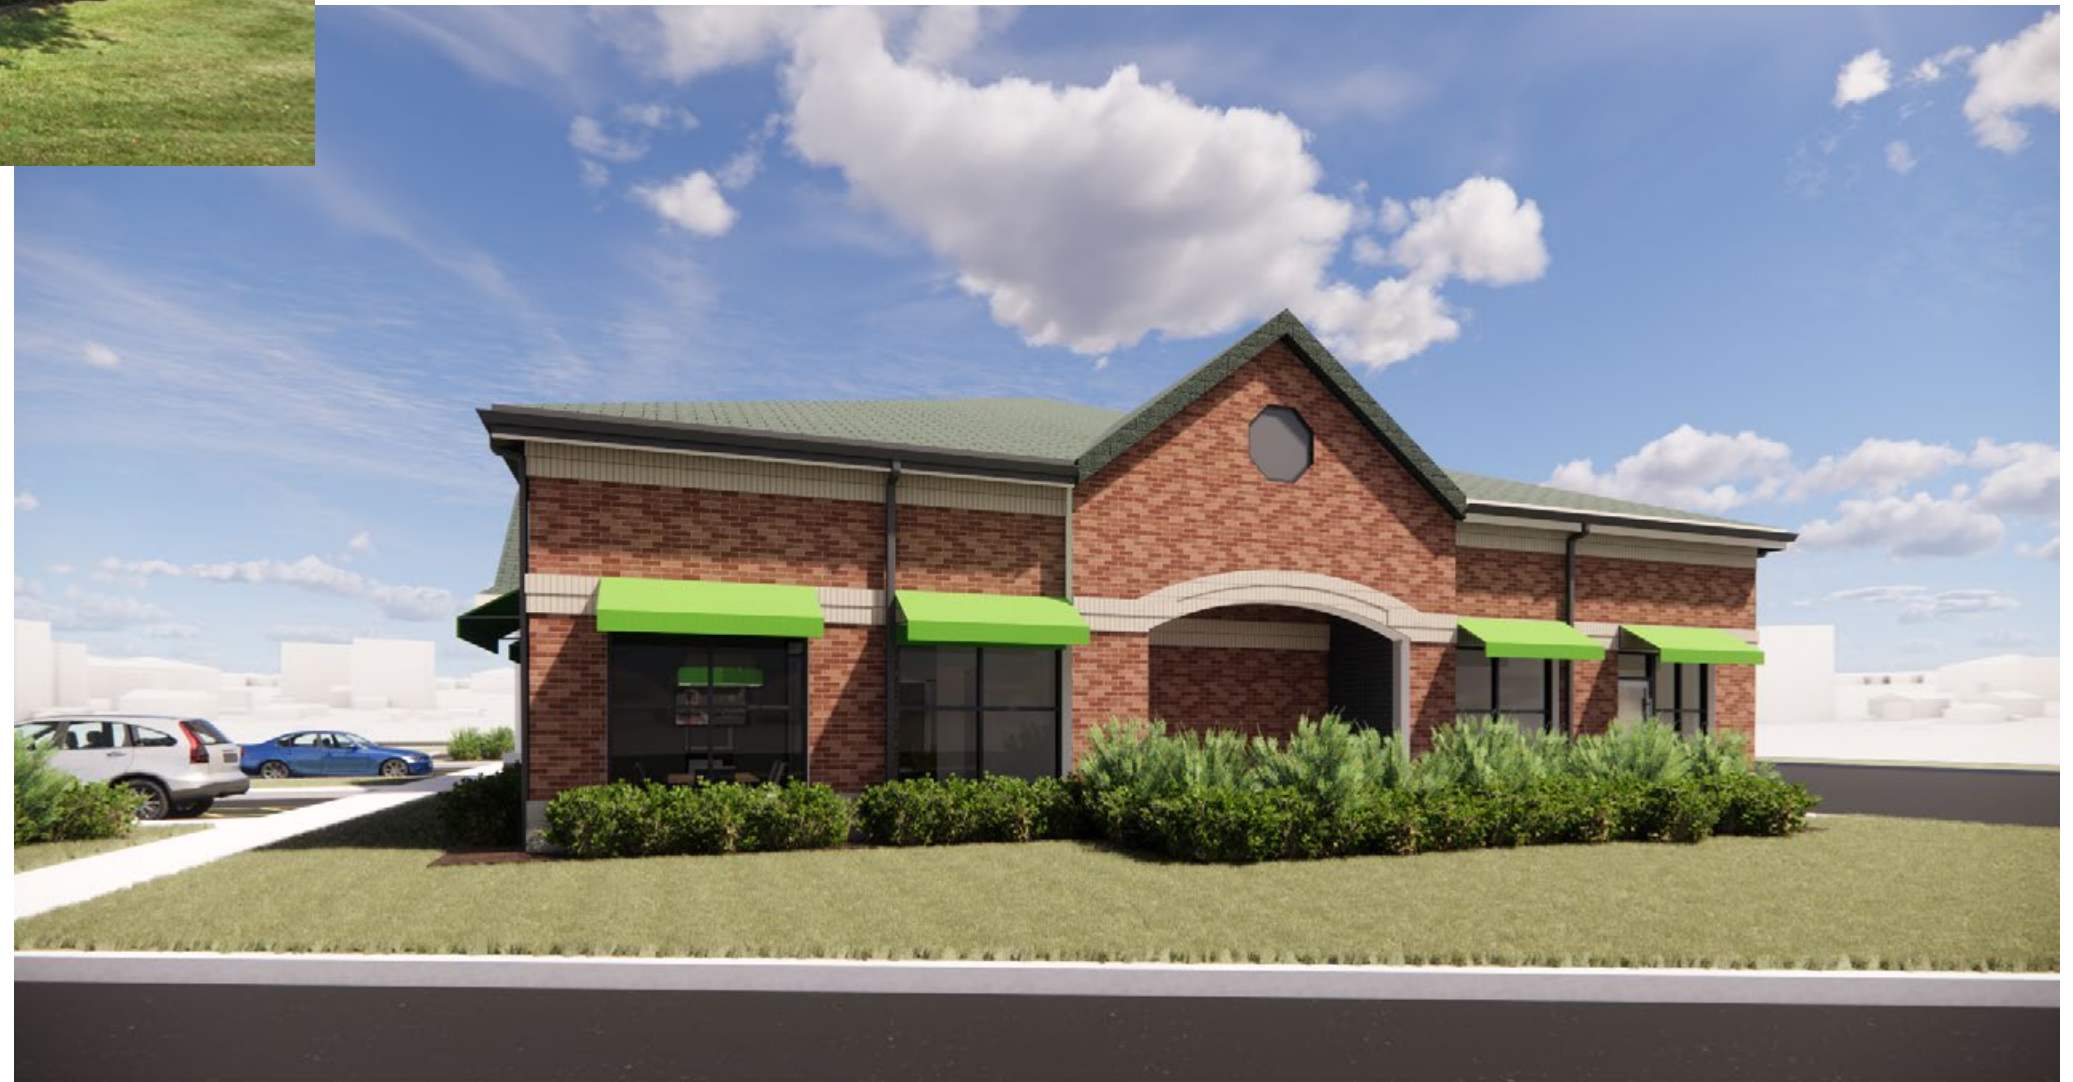
- Existing exterior to remain.
- Install fabric awnings over windows and exit door.

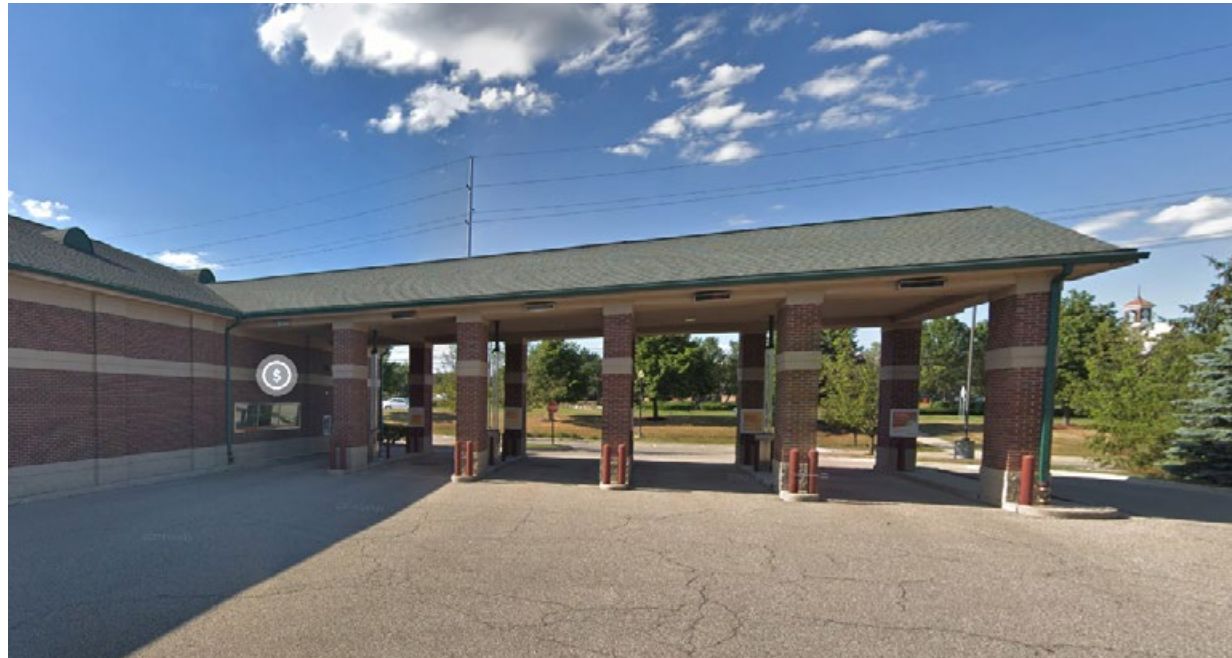
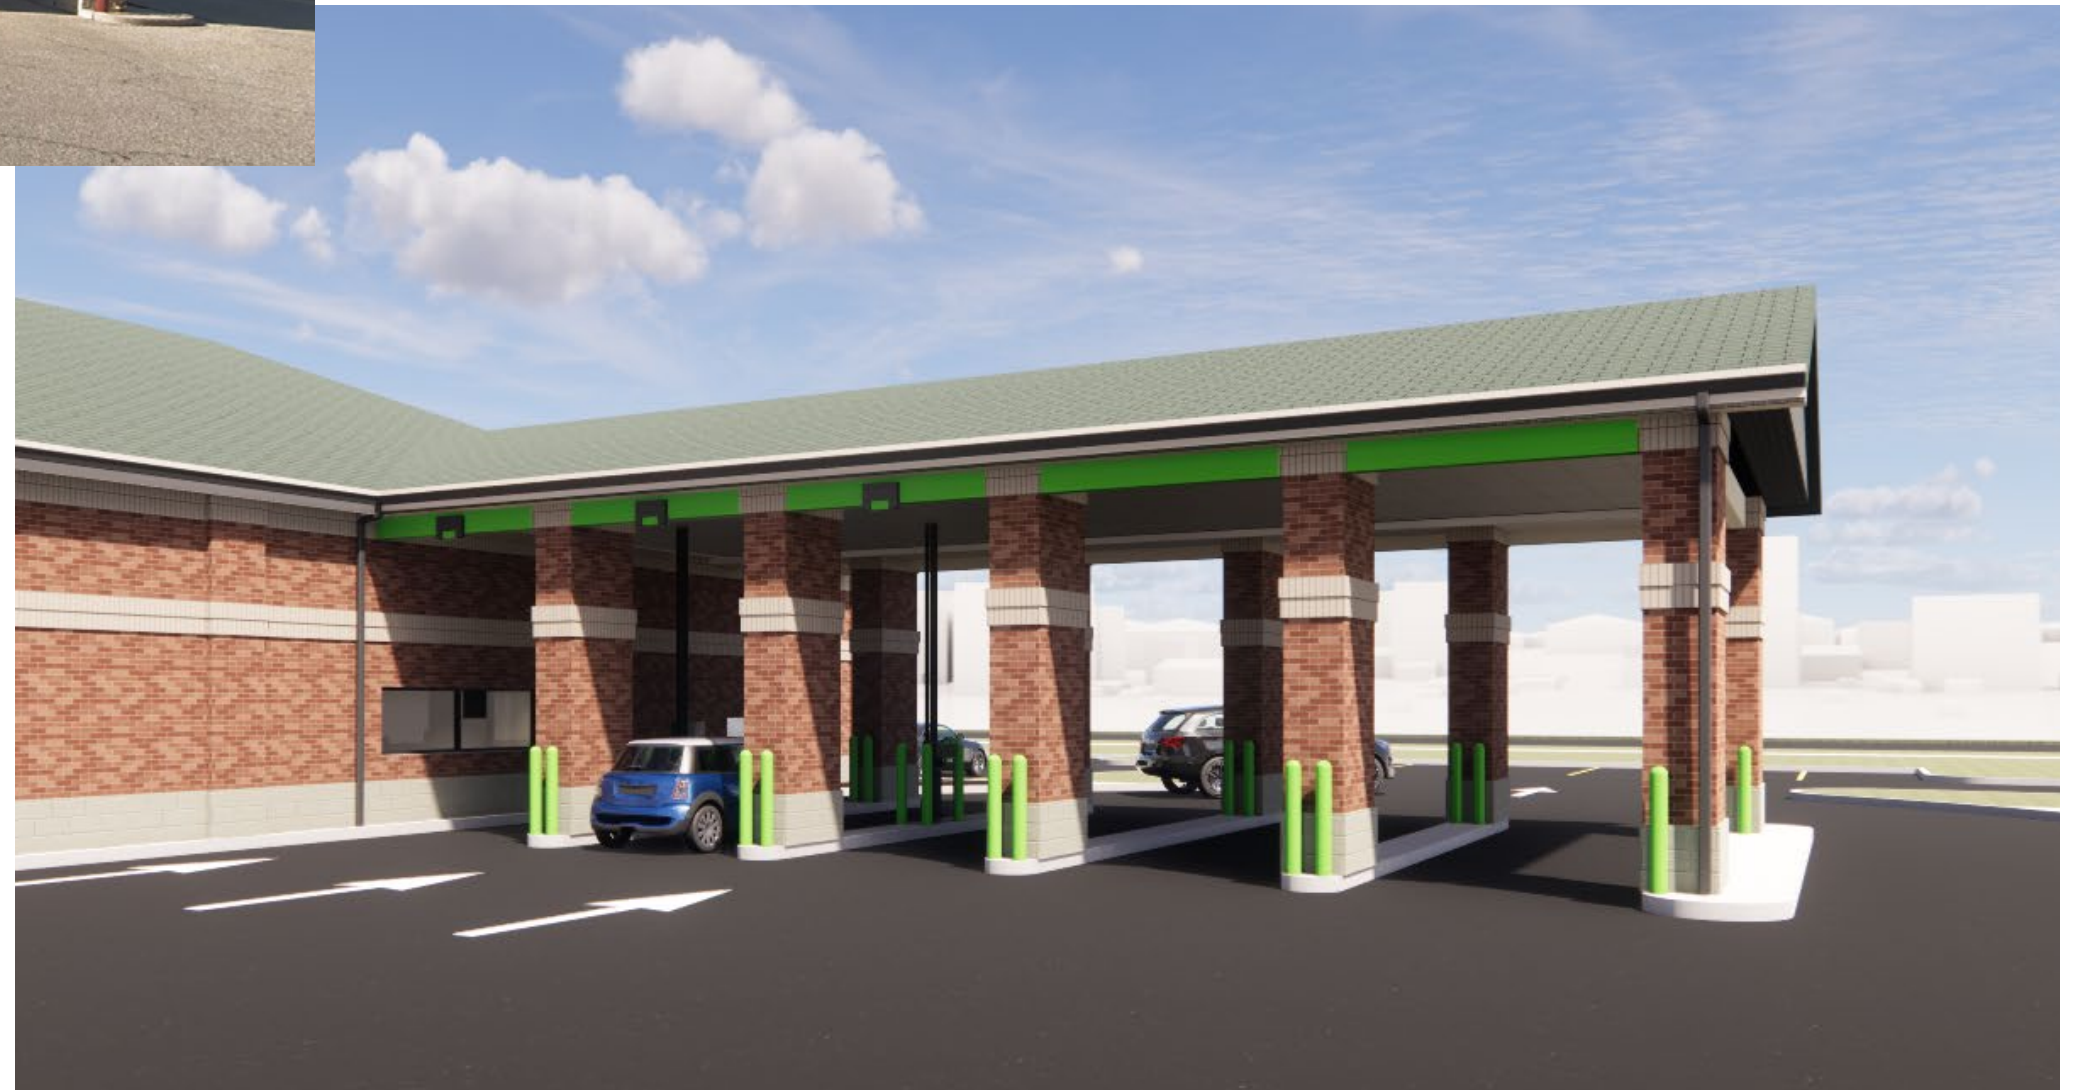
- Replacement of drive-up teller window and bank equipment.
- Existing brick piers to remain.
- Increase fascia height to install signage.
- Signage to include removeable green backing element. Green visible on this side only - existing to remain on short side and facing 6 Mile Rd
